Manhole Inspection Summary

Manhole # S13OO1018MH

Insp Date: **11/29/06 9:14 AM**

Location Address: **2808 WOODLAND AVE**

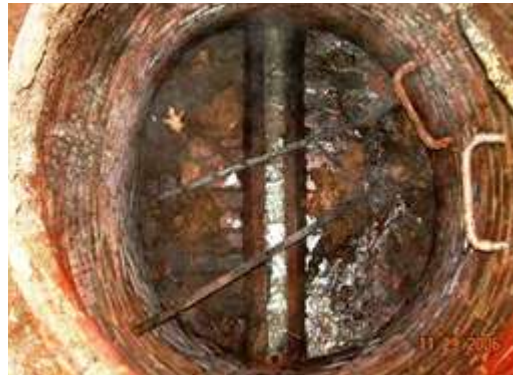
Top View

Evidence of surcharge - Bench debris.
Corroded steps.

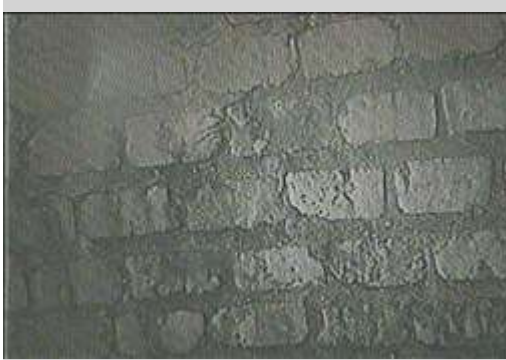
Defect

Corbel and Barrel infiltration.

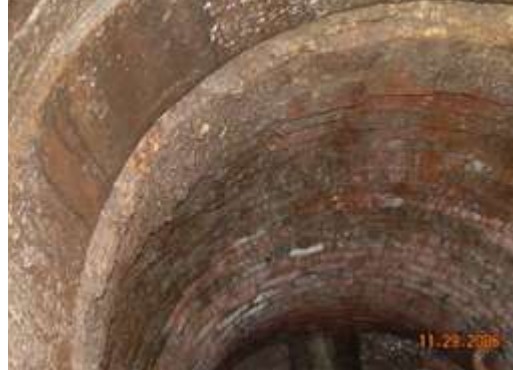
Defect

Frame leaks. Adjustment, Corbel, and
Barrel infiltration.

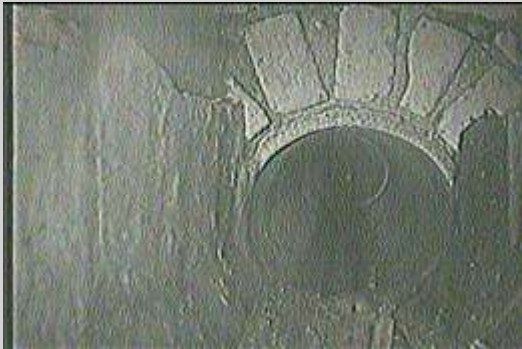
8 in. Circular Gravity Sewer Pipe Out @ 12 O'Clock

Infiltration: **None** Pipe Seal Cond: **Unknown**

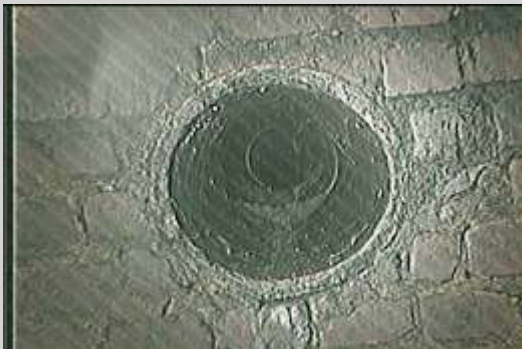
8 in. Circular Gravity Sewer Pipe In @ 6 O'Clock

Infiltration: **Evidence** Pipe Seal Cond: **Unknown**

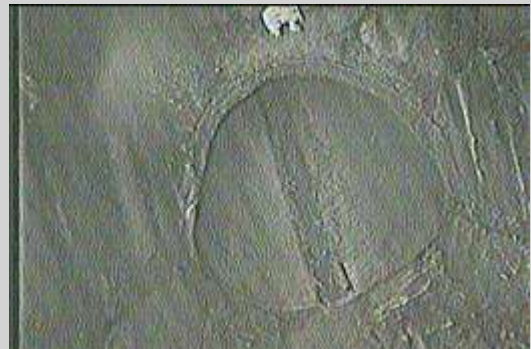
Drop In @ 6 O'Clock

Drop Condition: **Open**
